Drinking water 2018

Quarter 2

A report by the Chief Inspector of Drinking Water

Drinking water 2018
Public water supplies for
England and Wales

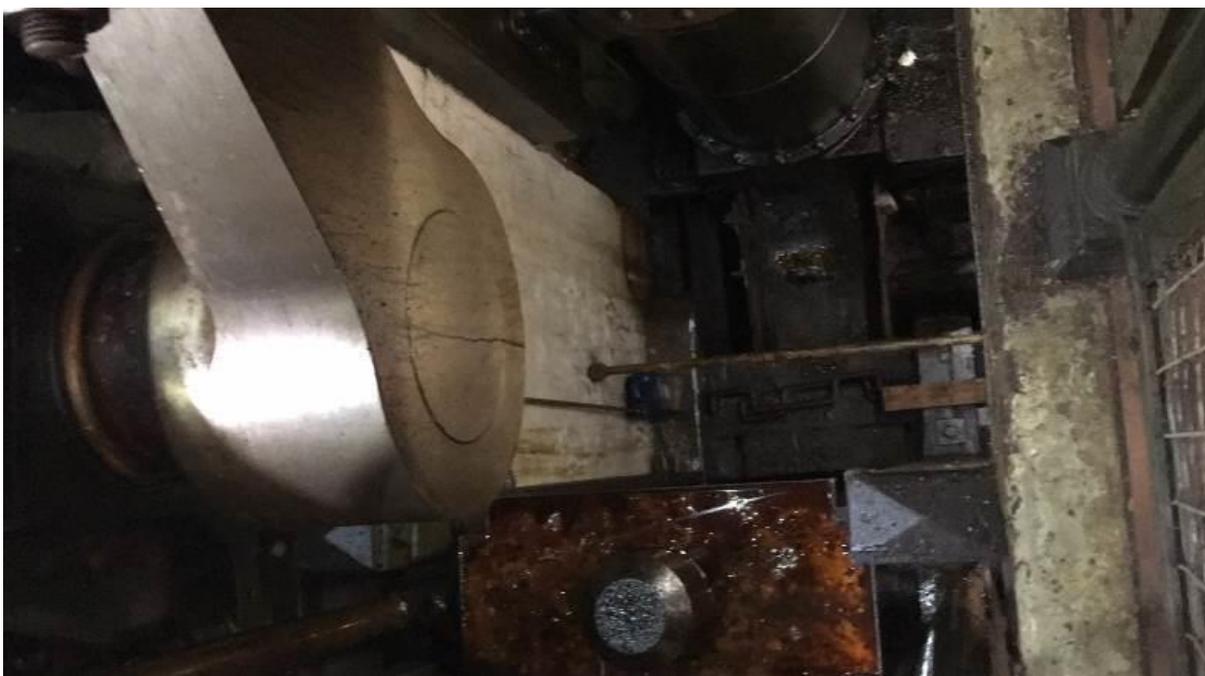
Severn Trent Water's Papplewick works is unusual in that the original well building has become a heritage site open to the public, who have the opportunity to see the original steam pump and, on special occasions, witness it in operation. This arrangement presents some challenges as there is little demarcation of the site into public and operational areas. The operational buildings were secure, but there are increased risks to the source from the public activity and the Inspectorate required the company to review the security arrangements. There was little control of the use of hazardous substances and it was found that the old well was not appropriately sealed to prevent contamination. Subsequently the Inspectorate served a Notice on the company to prevent contamination via this route.

Figure 1: Contamination Risks from the Old Well at Papplewick

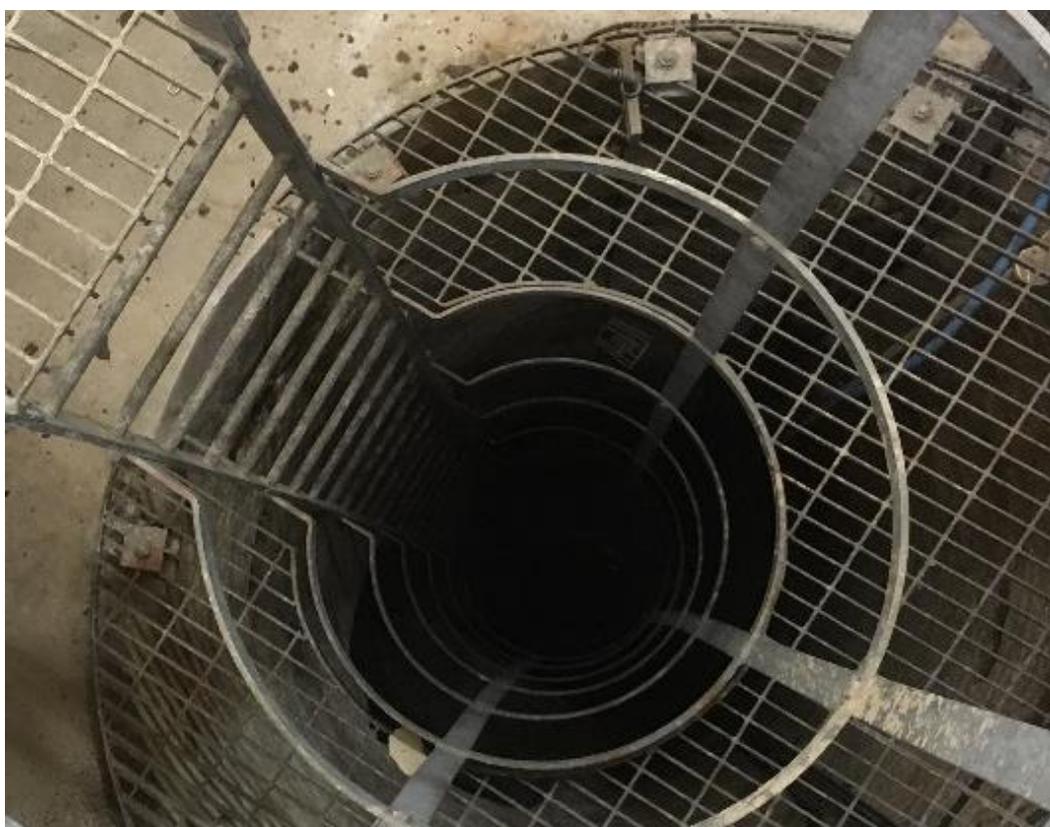
Similarly at Connaught Well, in Dover, the Inspectorate found contamination risks to the wells, but the company considered the risks bearable due to geology, aquifer levels and the well being housed inside a building and are taking no action. Water companies bear the duty of determining the risk of hazards within their supply and equally the duty for wholesomeness. Where a risk is identified there is an expectation that it is periodically reviewed to determine if the risk remains tolerable or a plan is required to mitigate challenges. Were and incident to occur the absence of any determination in the risk assessment would be taken into consideration in decisions on enforcement.

Figure 2: Connaught Well direct access to the adit system - contamination risk.

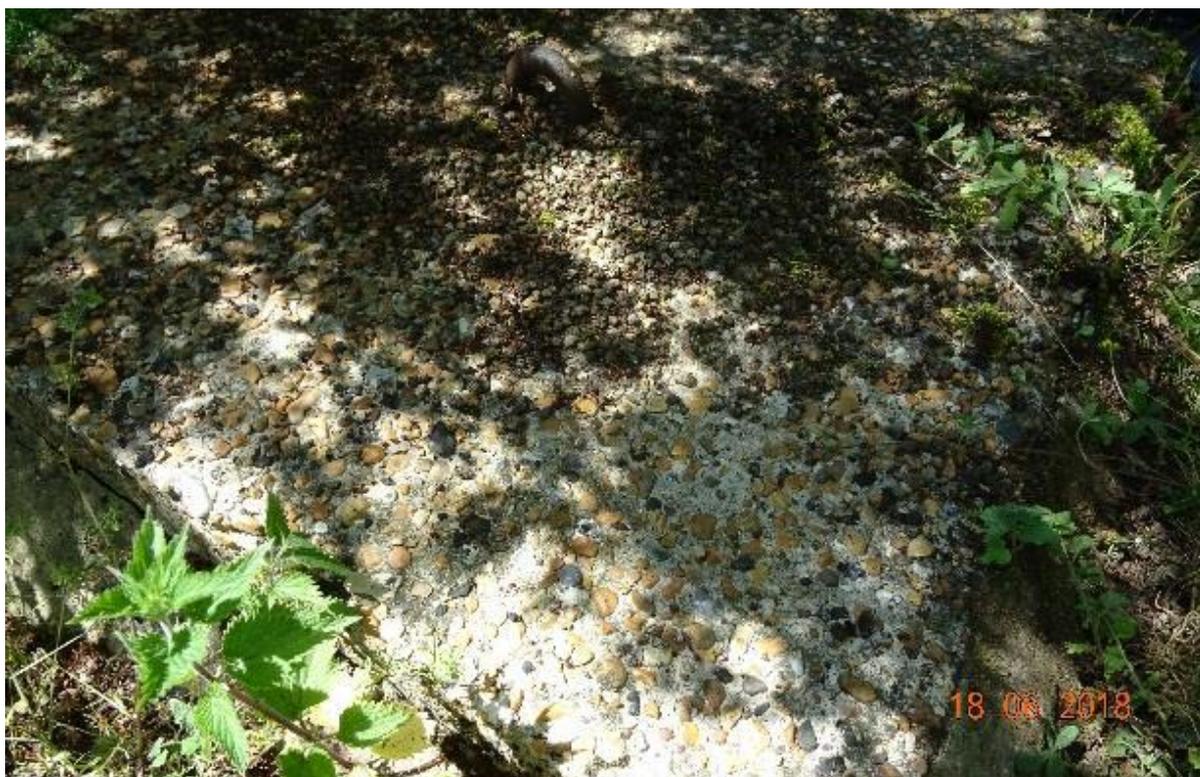
At Southern Water's Patcham works the Inspectorate viewed abandoned wells that were decommissioned in the 1950s. The engineering to decommission the wells does not meet modern standards and poses a very high risk to the source water at this site. For example, one well that was located approximately 300m away up a reasonably steep incline, in a meadow. It was covered with a loose fitting concrete plinth and there was a significant amount of animal faecal matter on and around this plinth presenting an obvious ingress risk.

Figure 3: Patcham Works - Poorly protected abandoned well

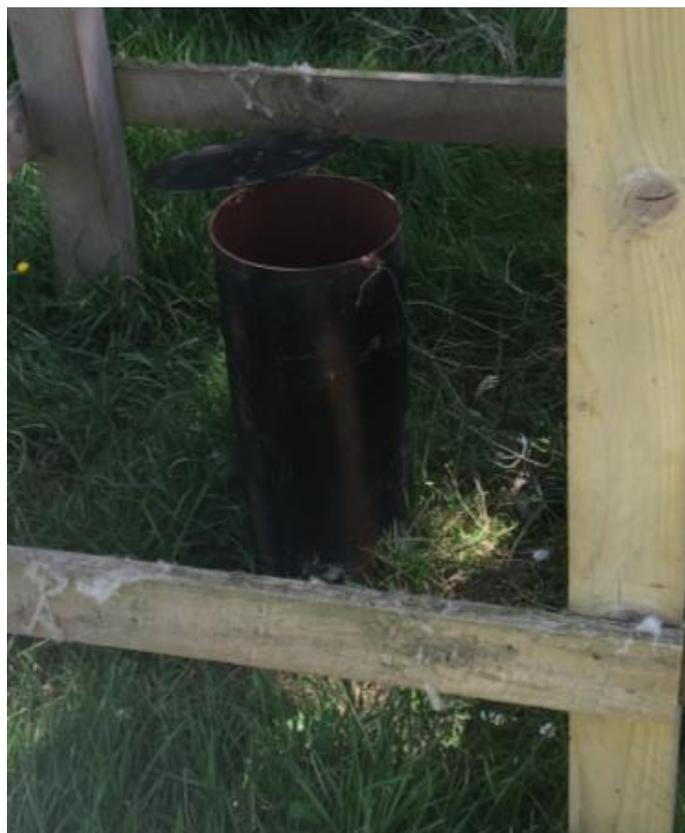
Risks were identified by the audit team on an observational borehole supplying Fowberry works. The lock on the observation borehole had been cut off, leaving the borehole at risk of contamination by unauthorised access.

Figure 4: Fowberry observation borehole without padlock
