Drinking water 2020

Quarter 2

April - June 2020

A report by the Chief Inspector of Drinking Water

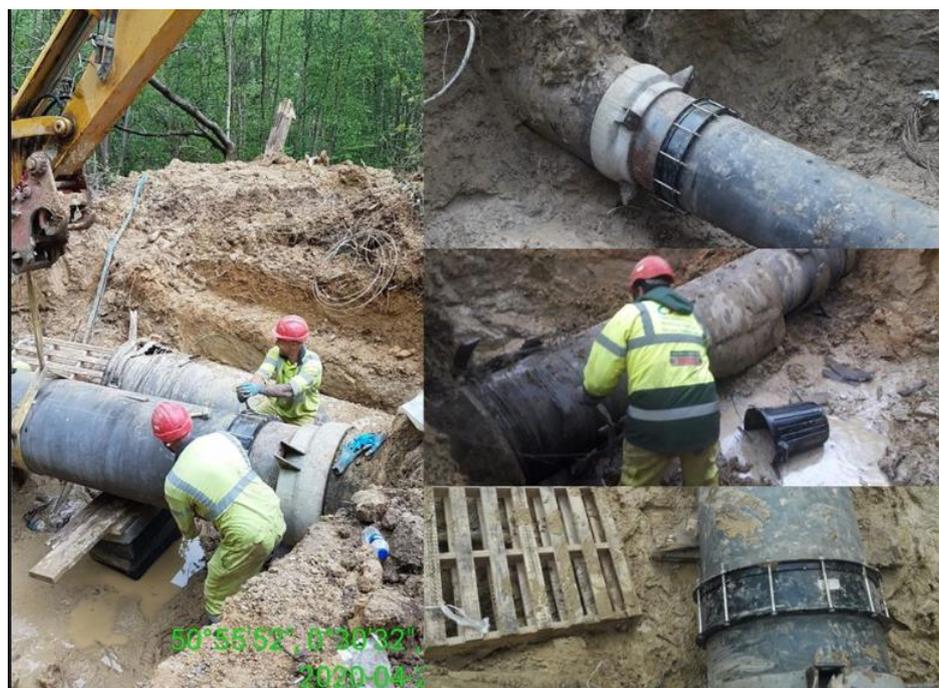
Figure 1. Leaking raw water main and the repair operation

The first consumer contacting the company reporting a loss of supply was received at 13:00 hours on 27 April. The operation to repair to the raw water main commenced on 26 April, but the work was complicated and difficult due to access restrictions and some equipment malfunction. By 13:00 on 27 April the repair had been completed and the main was being slowly recharged so as not to cause any additional bursts. The supply from the works was restored at 21:30 that evening and supplies from Baldslow SR recommenced at 02:00 on 28 April. As the distribution network had been drained there were several airlocks within the system which meant that consumers on higher ground did not receive a water supply until the company carried out valving operations to remove the airlocks.

Southern Water is to be commended for the relatively short duration of the loss of supplies that occurred as a consequence of the burst raw water main at Beauport works, which is a strategic asset and the sole source of supply to several thousand consumers. The consequences could have been more serious if the repair had taken longer, with a larger population suffering a loss of supply and greater risks to water quality. The CoViD-19 restrictions in place presented additional challenges which would have increased the inconvenience for consumers, with potentially serious difficulties for shielding consumers.

This serious event highlights the risks associated with single points of failure, where the event was caused by the failure of a critical asset without the ability to supply raw water to Beauport works by another means. Southern Water should use this event to update its risk assessment for Beauport works and consider addressing this risk in its future investment plans.
