EXPOSURE TO ENDOCRINE DISRUPTERS VIA  
MATERIALS IN CONTACT WITH DRINKING WATER  
- PHASE 2 -

DWI 70/2/88(II)

Final Report to DEFRA/DWI

Report date: Sept 2001

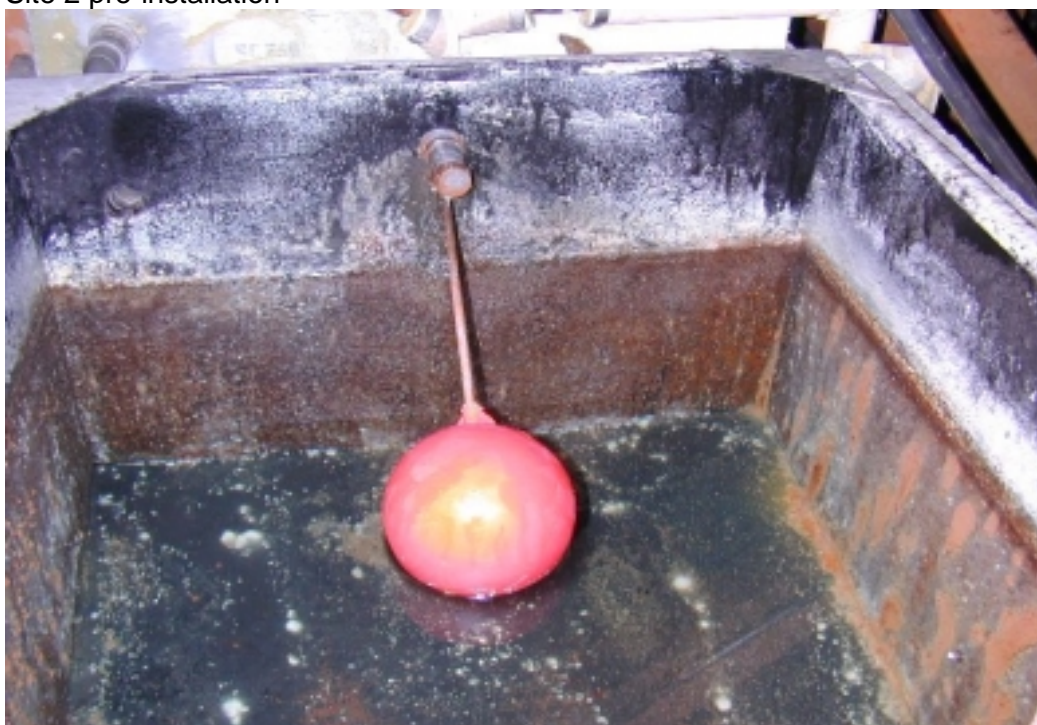
Site 2 pre-installation

Type of building	Office with staff kitchen
People using building	100 staff
Tank capacity (pre- refurbishment)	1000 litre bitumin lined galvanised tank
Tank capacity (post-refurbishment)	1000 litre butyl rubber relining
Dimensions of refurbished tank	1.5m x 1.0m x 1.0m
Refurbishment product	Butyl rubber liner

## Site 2 - Bitumen coating replaced with butyl liner

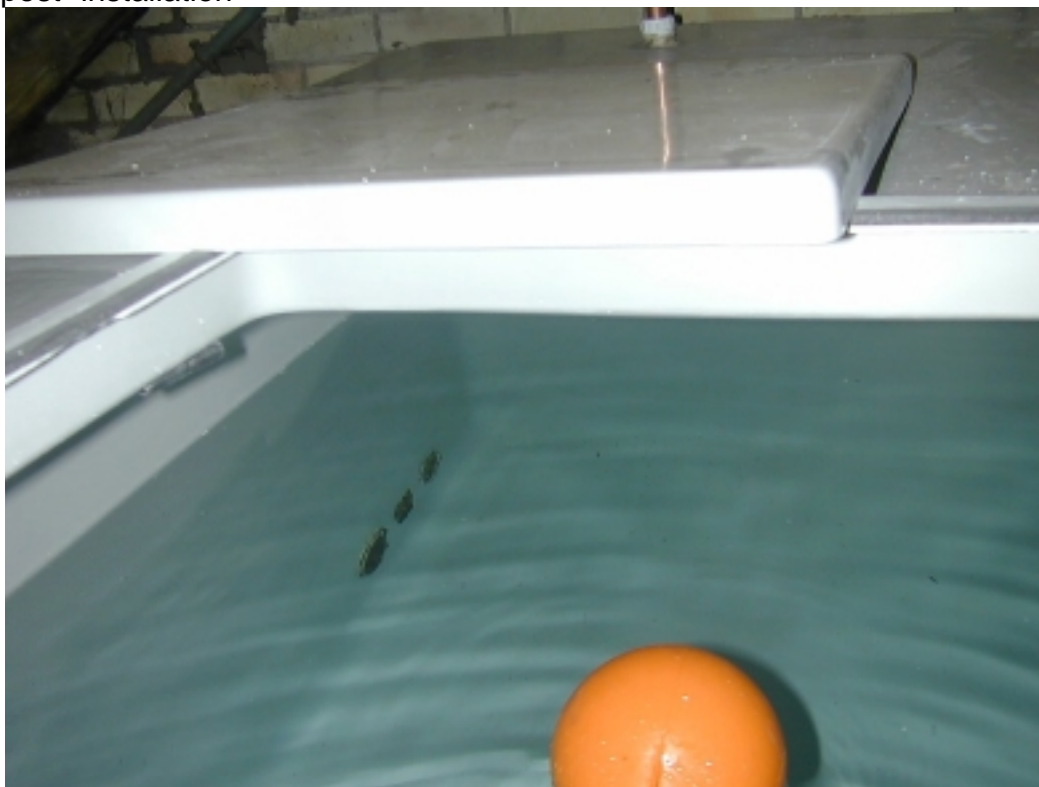
Site 3 post -installation

Type of building	School
People using building	125 staff and pupils
Tank capacity (pre- refurbishment)	Not known
Tank capacity (post-refurbishment)	1589 litres GRP tank
Dimensions of refurbished tank	1.52m x 1.11m x 0.91m
Refurbishment product	Replacement GRP tank

**Site 3 - Galvanised tank replaced with GRP tank**
